# Manhole Inspection Summary

Manhole # S17I\_\_007MH

Insp Date: **2/27/08 8:12 AM**

**Location** Address: **2538 booth st**

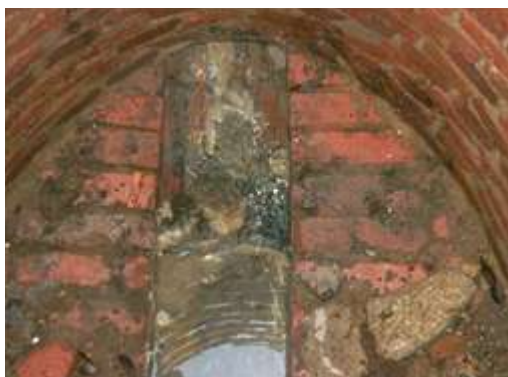
Defect 6

Condition: ☐ Sound ☐ Cracked ☐ Root Intrusion ☐ Deteriorated ☐ Leaks ☒ **Debris**

debris blocking channel

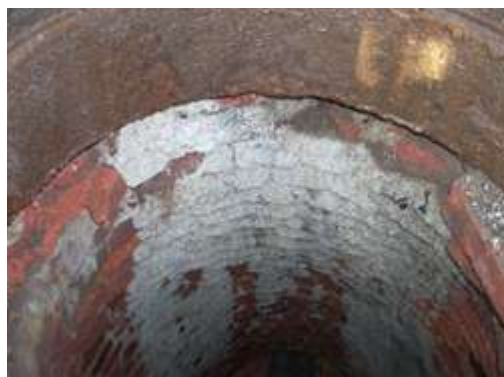
Defect 5

Infiltration: ☐ None ☒ **Joint** ☐ Cracks ☐ Mortar ☐ Roots ☐ Wall

infiltration of the corbel joint

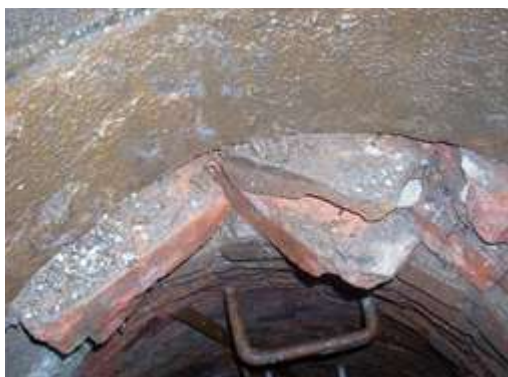
Defect 4

Condition: ☐ Sound ☐ Cracked ☐ Root Intrusion ☒ **Loose Brick** ☒ **Deteriorated**

loose corbel bricks

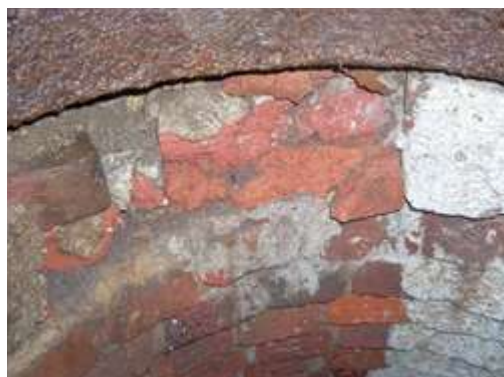
Defect 3

deteriorated corbel

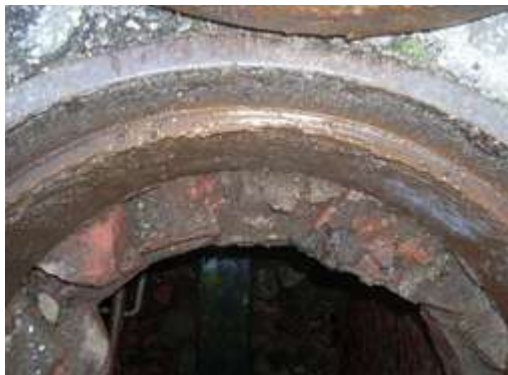
Defect 2

**Frame** Offset: **5** (in.) Condition: ☒ Sound ☐ Cracked ☐ Leaks

frame offset

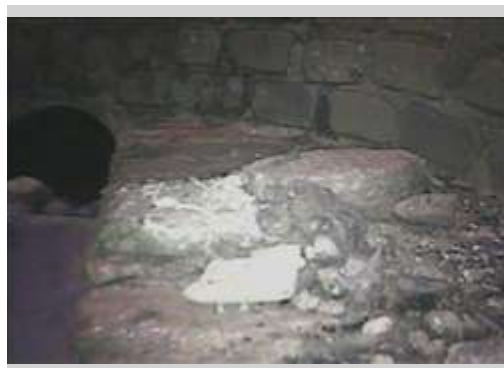
Defect 1

debris on the bench

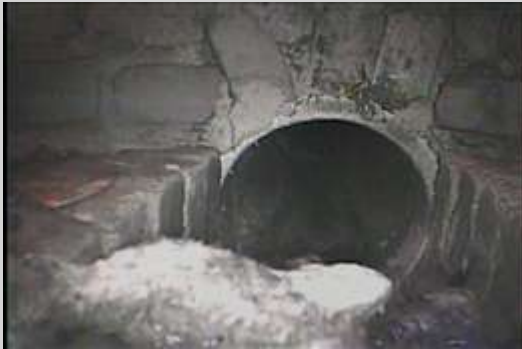
12 O'Clock Outflow

8 in. Circular Gravity Sewer  
Pipe Out @ 12 O'Clock

Pipe Height: **8.4** (in.) Rod and Bar (Angled)  
Pipe Material: **Clay** ☐ Pipe Lined  
Invert Depth: **7.54** (ft.) Flow Characteristics: **Slow**  
Deposits: ☒ None ☐ Mud ☐ Sludge ☐ Debris ☐ Grease  
Silt Depth: **0** (in.) Deposits Extent:  
Infiltration: **None** Pipe Seal Cond: **Sound**

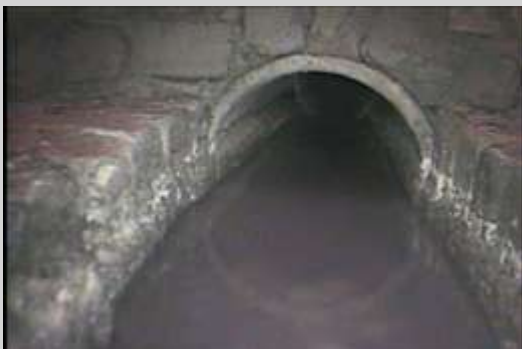
6 O'Clock Inflow

8 in. Circular Gravity Sewer  
Pipe In @ 6 O'Clock

Pipe Height: **8.4** (in.) Rod and Bar (Angled)  
Pipe Material: **Clay** ☐ Pipe Lined  
Invert Depth: **7.43** (ft.) Flow Characteristics: **Slow**  
Deposits: ☒ None ☐ Mud ☐ Sludge ☐ Debris ☐ Grease  
Silt Depth: **0** (in.) Deposits Extent:  
Infiltration: **None** Pipe Seal Cond: **Sound**
